# **INDOOR AIR QUALITY ASSESSMENT**

**Watertown Fire Department, Station 2  
534 Mount Auburn Street  
Watertown, Massachusetts**

Prepared by:  
Massachusetts Department of Public Health  
Center for Environmental Health  
Bureau of Environmental Health Assessment  
Emergency Response/Indoor Air Quality Program  
March 2005

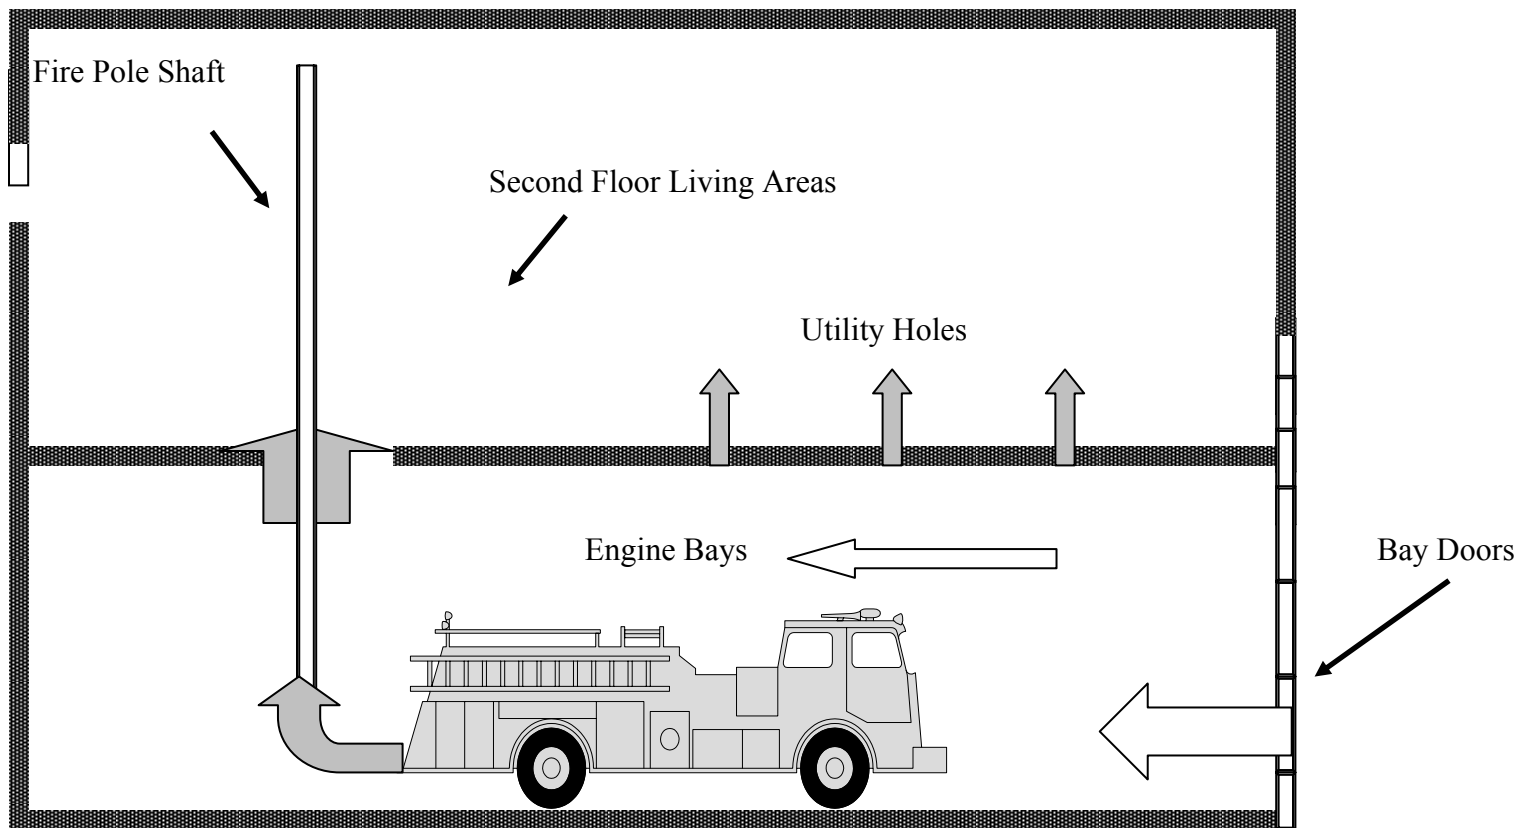
Figure 1

A number of pathways for vehicle exhaust and other pollutants to move from the engine bays into occupied areas on both the first and second floors were identified (Figure 1). The main pathway for vehicle exhaust emissions is the stairwell off the engine bay, which lacks a door at its base (Picture 10). Without an air-tight door vehicle exhaust odors, carbon dioxide and UFPs were migrating into and pooling within the stairwell (Tables 1 and 2). The door at the top of the stairwell leading to the office areas and living quarters had spaces beneath the door (light could be seen penetrating through this space). The second floor windows were open during operation of fire fighting

Another possible pathway for exhaust emissions is through utility holes. The ceiling/walls of the engine bays are penetrated by holes for utilities. These holes can present potential pathways into occupied areas if they are not air-tight. Each of these conditions presents a pathway for air to move from the engine bays to occupied areas of the station. In order to understand how engine bay pollutants may be impacting the second floor and adjacent areas, the following concepts concerning heated air and creation of air movement must be considered:

Potential Pathways of Air and Pollutant Movement from Engine Bays into Occupied Areas\*

3. Install doors to stairwell leading off the engine bay. Seal doors on all sides with foam tape, and/or weather-stripping. Consider installing weather-stripping/door sweeps on both sides of doors with access to the engine bay to provide a duel barrier. Ensure tightness of doors by monitoring for light penetration and drafts around doorframes.

4. If possible, install an automatic control to activate the engine bay exhaust system as engine bay doors open.
5. Ensure all utility holes are properly sealed in both the engine bay and their terminus to eliminate pollutant paths of migration.

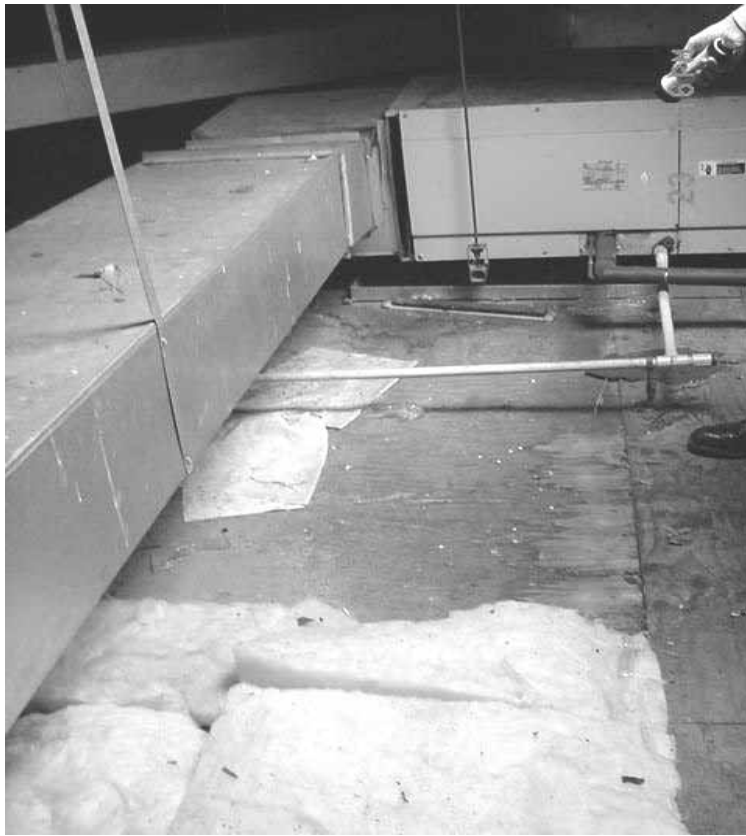
**Picture 1**

Air conditioning is provided by air handling units (AHUs) located in the attic (Picture 1). The AHUs do not have the capability to introduce outside air but recirculate air *only*. AHUs are ducted to wall or ceiling mounted air diffusers (Picture 2). Ceiling and wall-mounted return vents (Picture 3) draw air back to the AHUs via ductwork. These systems were not operating during the assessment. Station personnel could not confirm that a preventive maintenance program was in place for air handling equipment.

**One of Two Air Handling Units in the Attic**

6. Work with town officials to develop a preventative maintenance program for all HVAC equipment department wide.
7. Change filters for HVAC equipment as per the manufacturer's instructions or more frequently if needed. Consider increasing the dust-spot efficiency of HVAC filters. Prior to any increase of filtration, each piece of air handling equipment should be

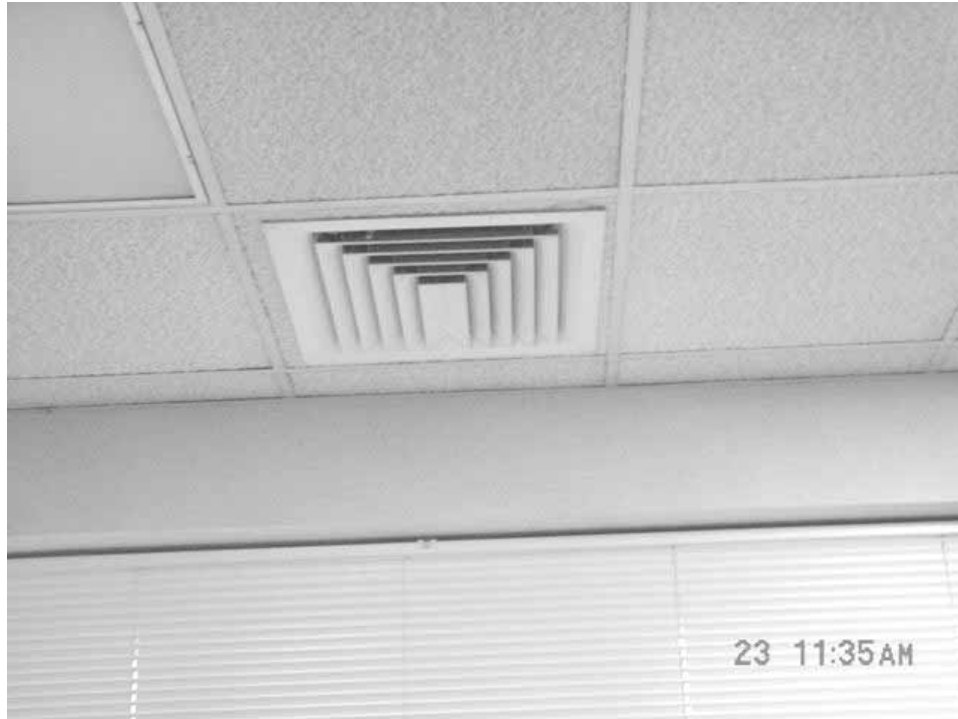
**Picture 2**

**Ceiling-Mounted Supply Vent for AC System**

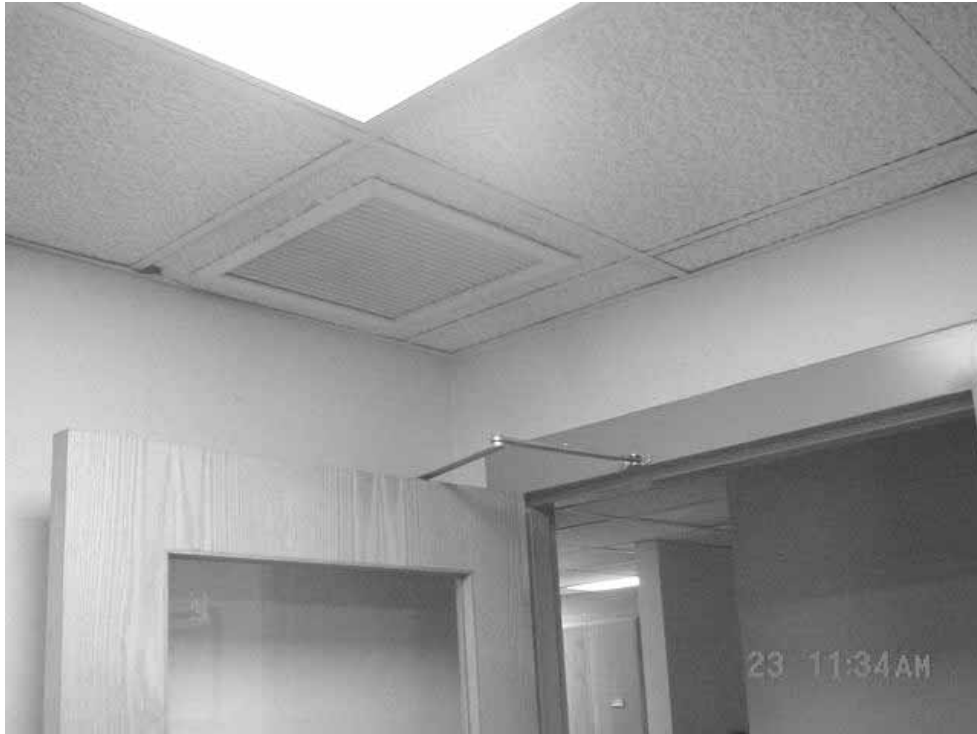
**Picture 3**

**Ceiling-Mounted Return Vent**

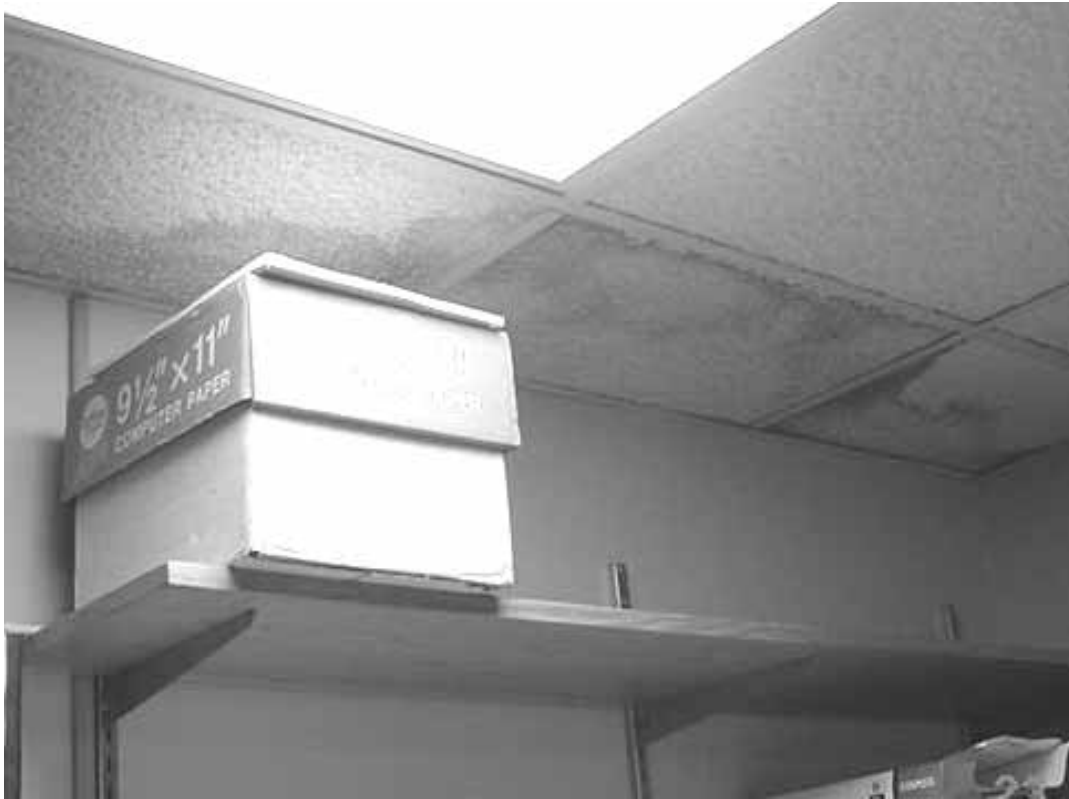
**Picture 4**

A number of areas had water-damaged ceiling tiles (Picture 4). Occupants reported that ceiling tiles became damaged as a result of condensation from air conditioning equipment during the cooling season. Water-damaged ceiling tiles can

provide a source of mold and should be replaced after a moisture source or leak is discovered and repaired.

**Water Damaged Ceiling Tiles**

9. Replace water-damaged ceiling tiles. Examine the area above and behind these areas for microbial growth. Disinfect areas of water leaks with an appropriate antimicrobial.

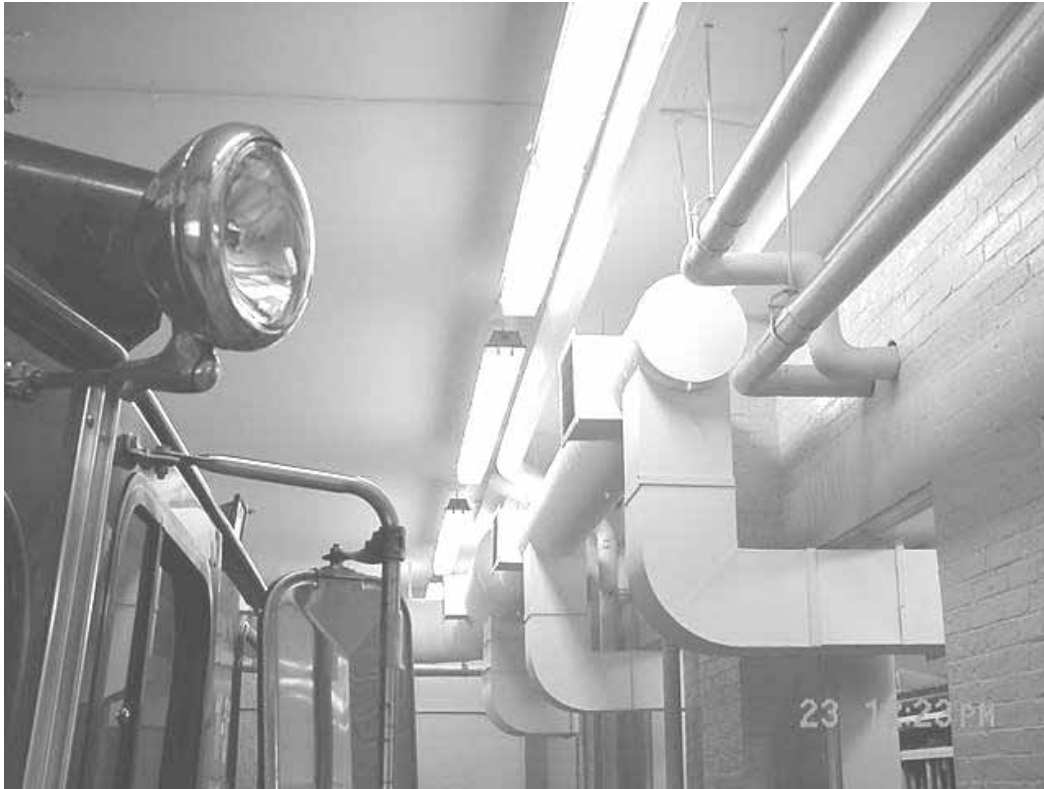
**Picture 5**

As mentioned previously, the station is equipped with a mechanical exhaust system to remove exhaust from the engine bay during vehicle idling. The local exhaust system consists of series of exhaust vents that feed into a main duct connected to a large exhaust motor located at the rear of the engine bay (Pictures 5 and 6). Make up air is provided through louvered vents that on exterior walls of the engine bay (Picture 7). The activation of this system appears to be dependent on a combination of chemical sensors (carbon monoxide and nitrogen dioxide) (Pictures 8 and 9). Once a pre-set reading is exceeded, the local exhaust system is activated to introduce fresh air and remove exhaust emissions.

**Engine Bay Exhaust Vents Feeding into the Main Exhaust Duct**

1. Manually activate local exhaust system upon exiting and returning to engine bays.
2. Contact the manufacture and/or installer regarding the operation and calibration of the of the chemical sensor/local exhaust ventilation system. Maintain and calibrate it in accordance with the manufacturer's instructions.

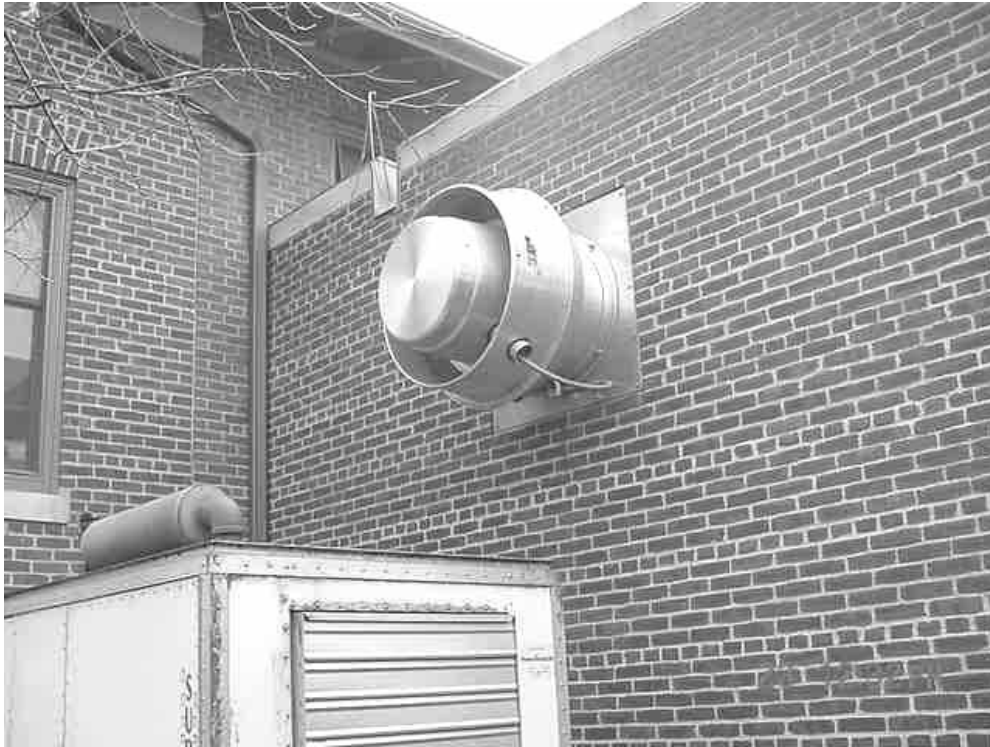
**Picture 6**

**Exhaust Motor for Engine Bay Exhaust System on Exterior of Building**

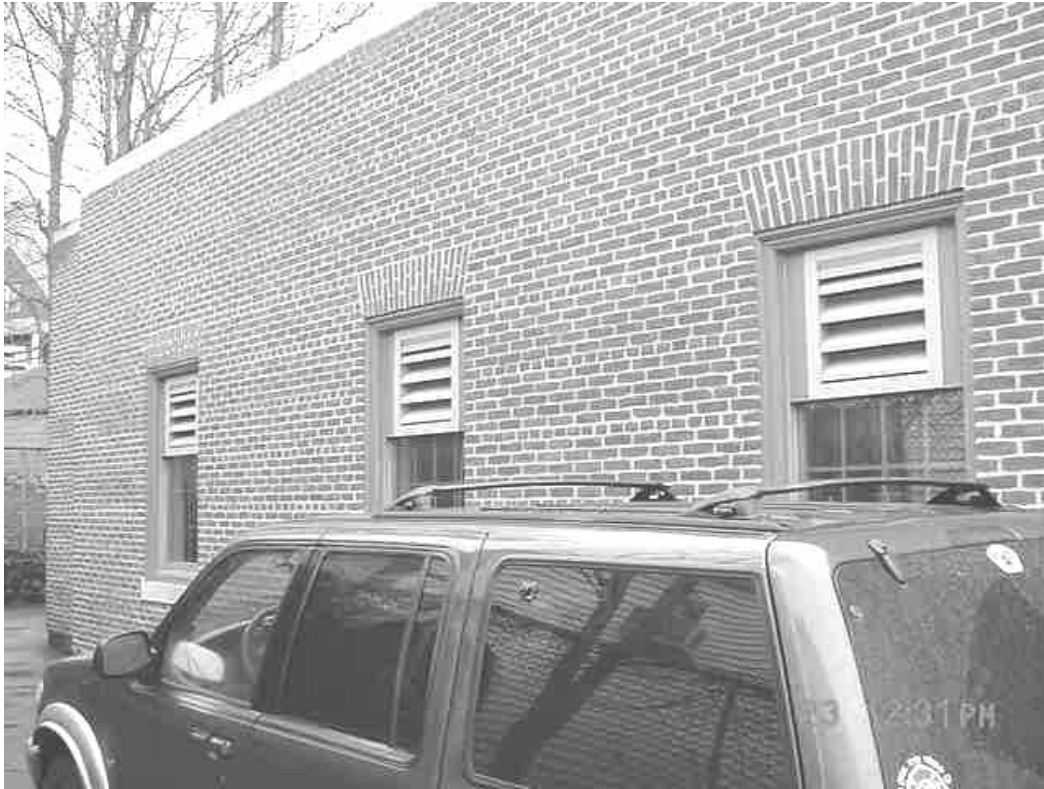
**Picture 7**

**Louvered Make-Up Air Vents for Engine Bay Exhaust System**

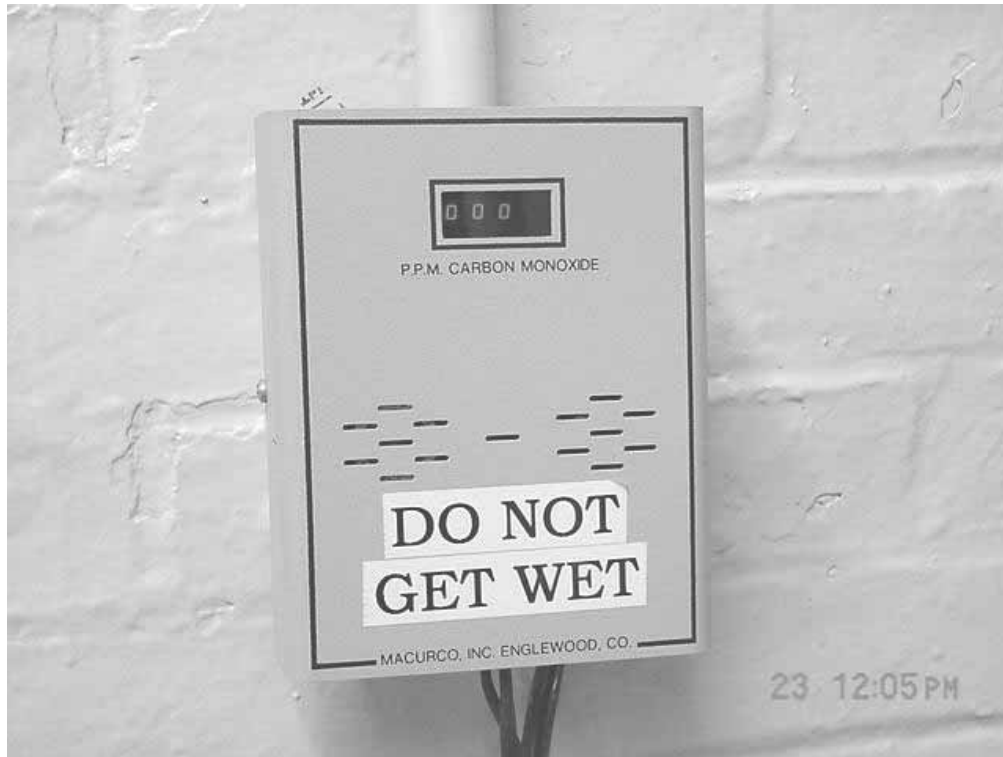
**Picture 8**

Therefore, no mechanical exhaust ventilation is provided until the set-point is exceeded to activate the system. As discussed, BEHA staff had the WFD personnel simulate a call, in which all fire-fighting and emergency support vehicles were started, removed from and returned to the engine bay. Neither during this activity nor after did the local exhaust system activate to remove vehicle emissions. In addition, WFD personnel could not identify what the set-points for the chemical sensors were nor the last time they were serviced and/or calibrated.

**Wall-Mounted Carbon Monoxide Sensor in Engine Bay**

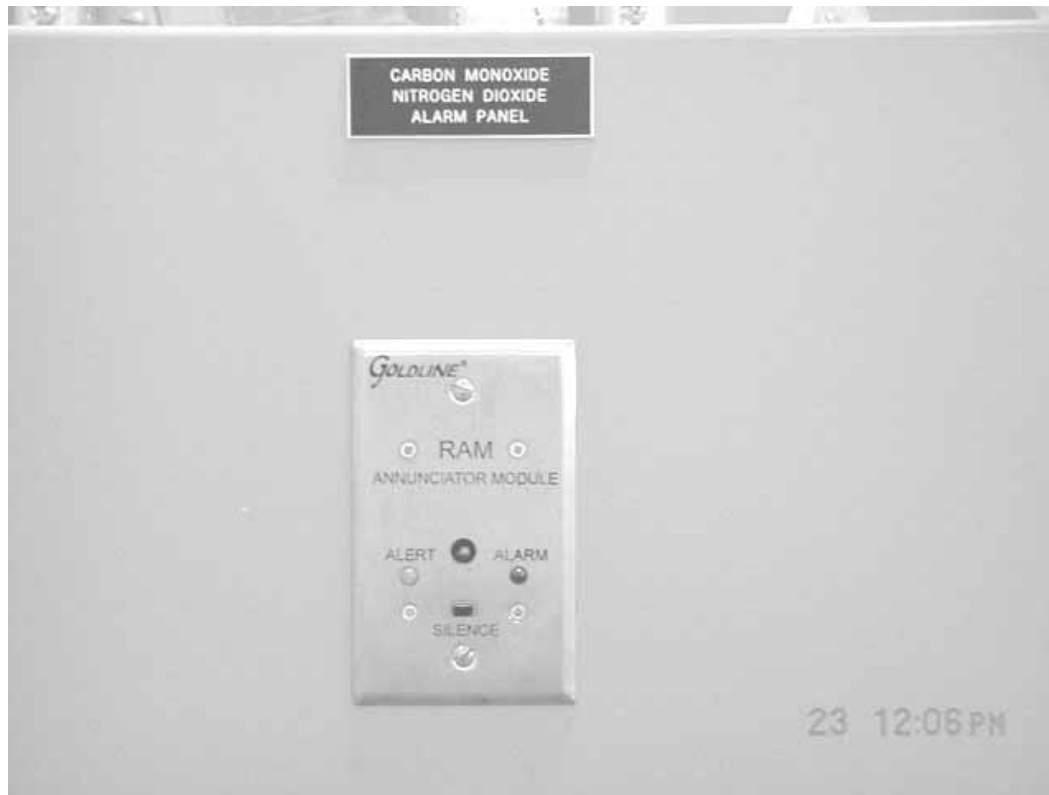
**Picture 9**

**Wall-Mounted Carbon Monoxide/Nitrogen Dioxide Alarm Panel in Engine Bay**

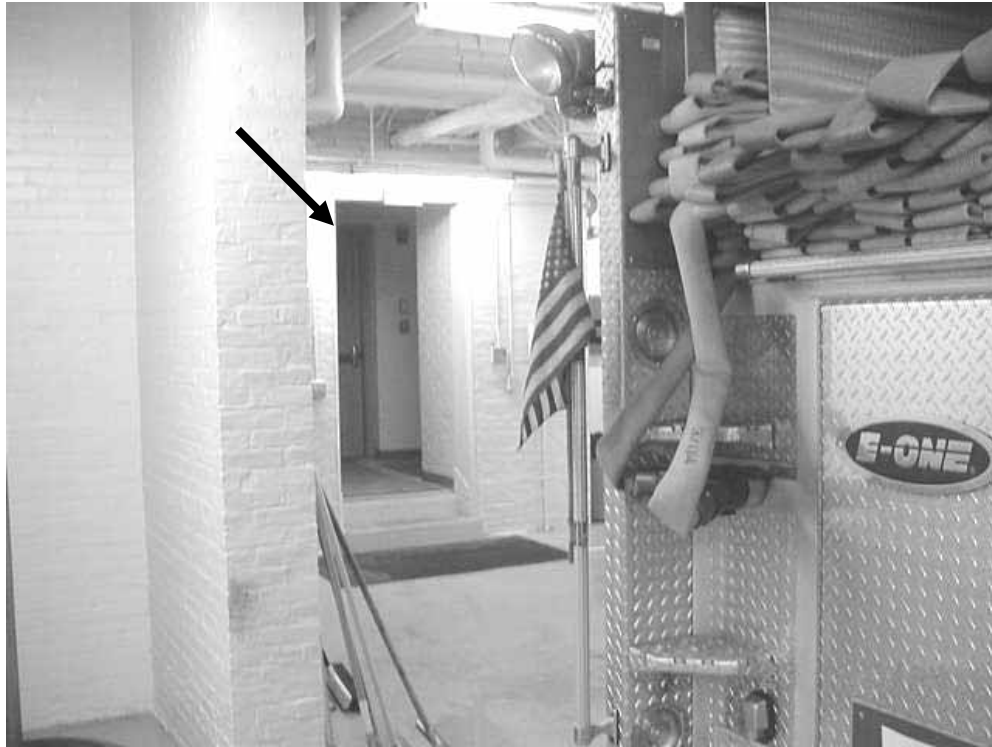
**Picture 10**

**View of Engine Bay/Stairwell Entrance from Directly Behind Engine, Note Lack of Door**

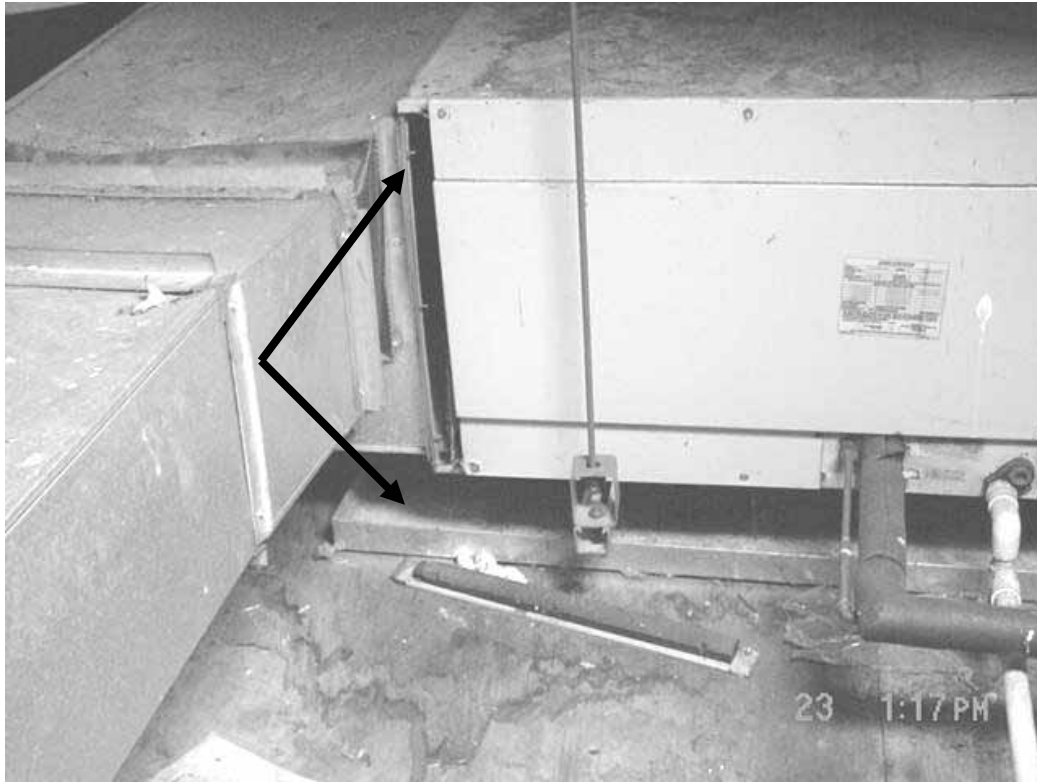
**Picture 11**

Several conditions that can potentially affect indoor air quality were also identified during the assessment. WFD staff could not identify the date of the last filter change in AC units. BEHA staff examined AHUs in the attic and found the filter access panel for one of the units was not installed (Picture 11). If not installed, the lack of the filter access panel will render the AHU casing non-air-tight and will draw air from the attic space into the unit. As air bypasses filters, the opportunity exists for airborne dirt, dust and particulates to be distributed to occupied areas via the HVAC system. Aerosolized dust, particulates and fiberglass can provide a source of eye, skin and respiratory irritation to certain individuals. In addition, these materials can accumulate on flat surfaces (e.g., desktops, shelving, and carpets) in occupied areas and subsequently be re-aerosolized causing further irritation.

**AHU in Attic, Note Filter Access Panel on Floor**

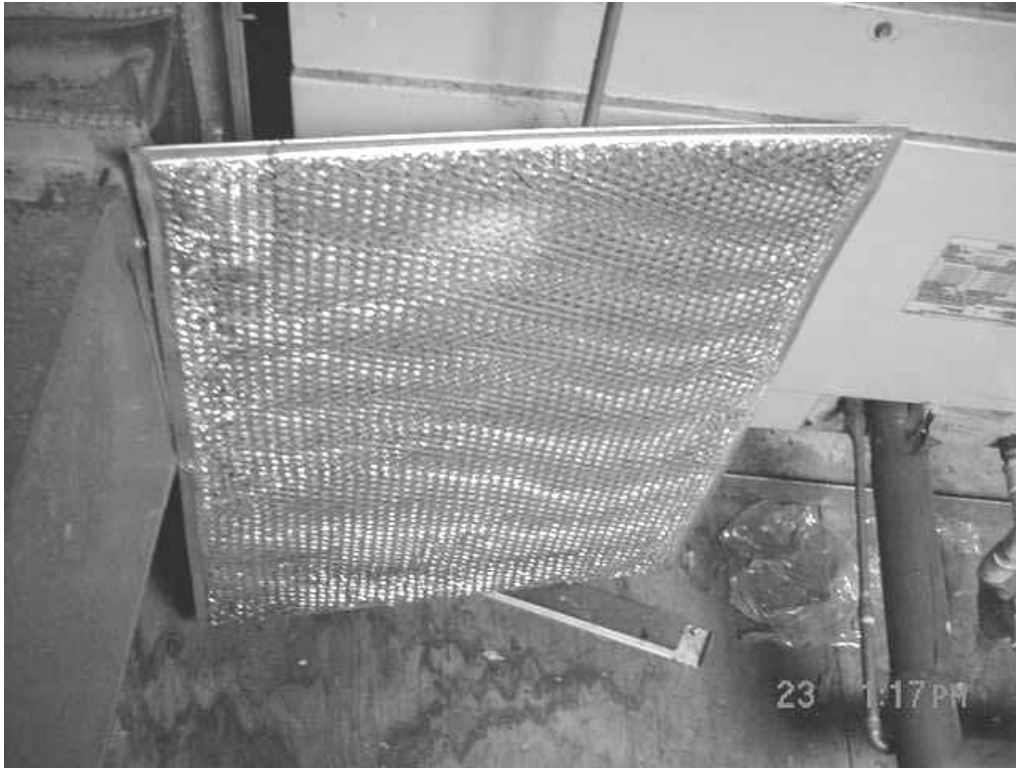
**Picture 12**

In addition, the type of filters installed in the units provides minimal respirable dust filtration (Picture 13). In order to decrease aerosolized particulates, disposable filters with an increased dust spot efficiency can be installed in AHUs. The dust spot efficiency is the ability of a filter to remove particulates of a certain diameter from air passing through the filter. Filters that have been determined by ASHRAE to meet its standard for a dust spot efficiency of a minimum of 40 percent would be sufficient to reduce airborne particulates (Thornburg, D., 2000; MEHRC, 1997; ASHRAE, 1992). Note that increased filtration can reduce airflow produced by the univent through increased resistance (called pressure drop). Prior to any increase in filtration, AHUs should be evaluated by a ventilation engineer to ascertain whether they can maintain function with more efficient filters.

**Wire Mesh Filter Installed in Attic AHUs**

evaluated by a ventilation engineer as to whether it can maintain function with more efficient filters.
